Re: Dam Safety Inspection Report, Little Falls Dam, Field File No. 55.01

Underwater Inspection

**Little Falls Dam
Willow River State Park
St. Croix County, Wisconsin**

Tainter Gate Inspection

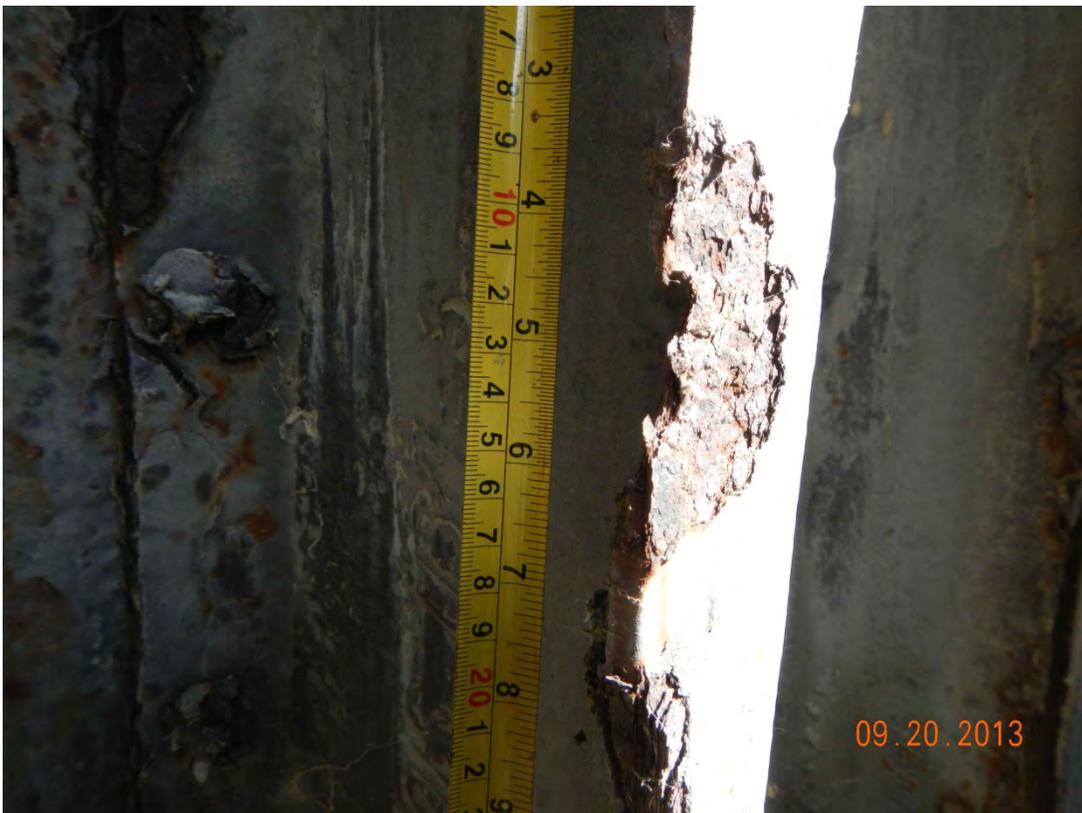
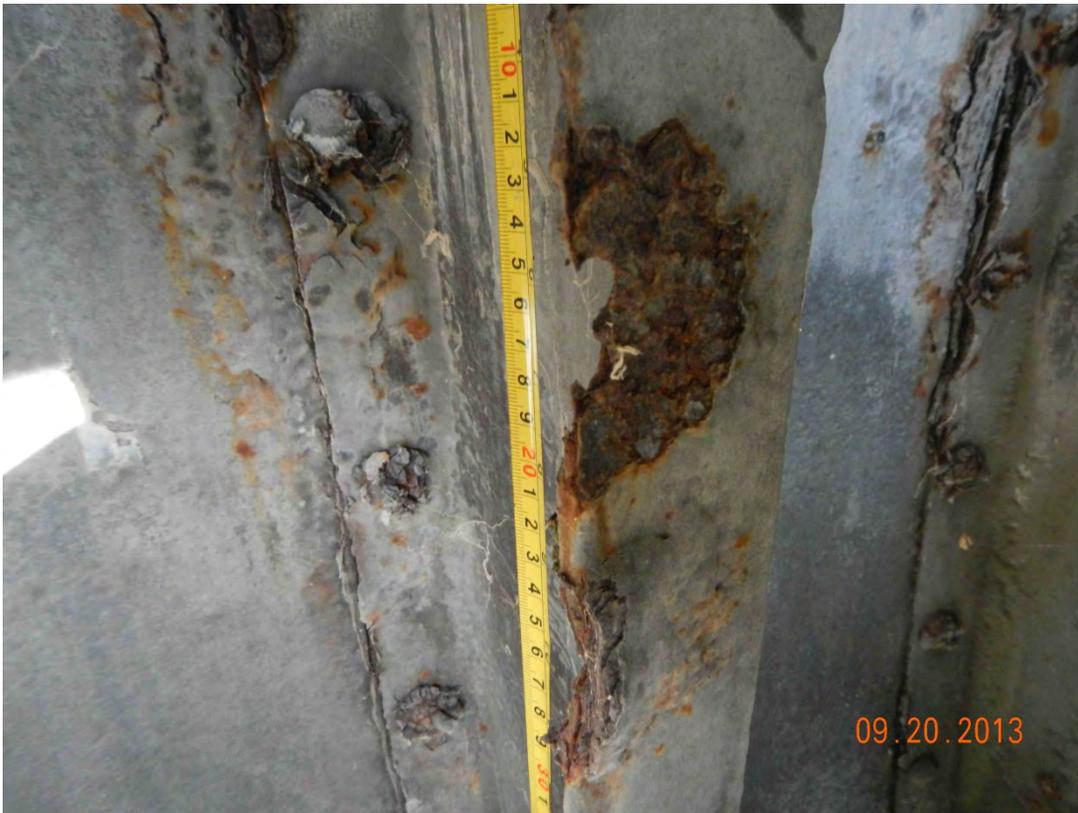
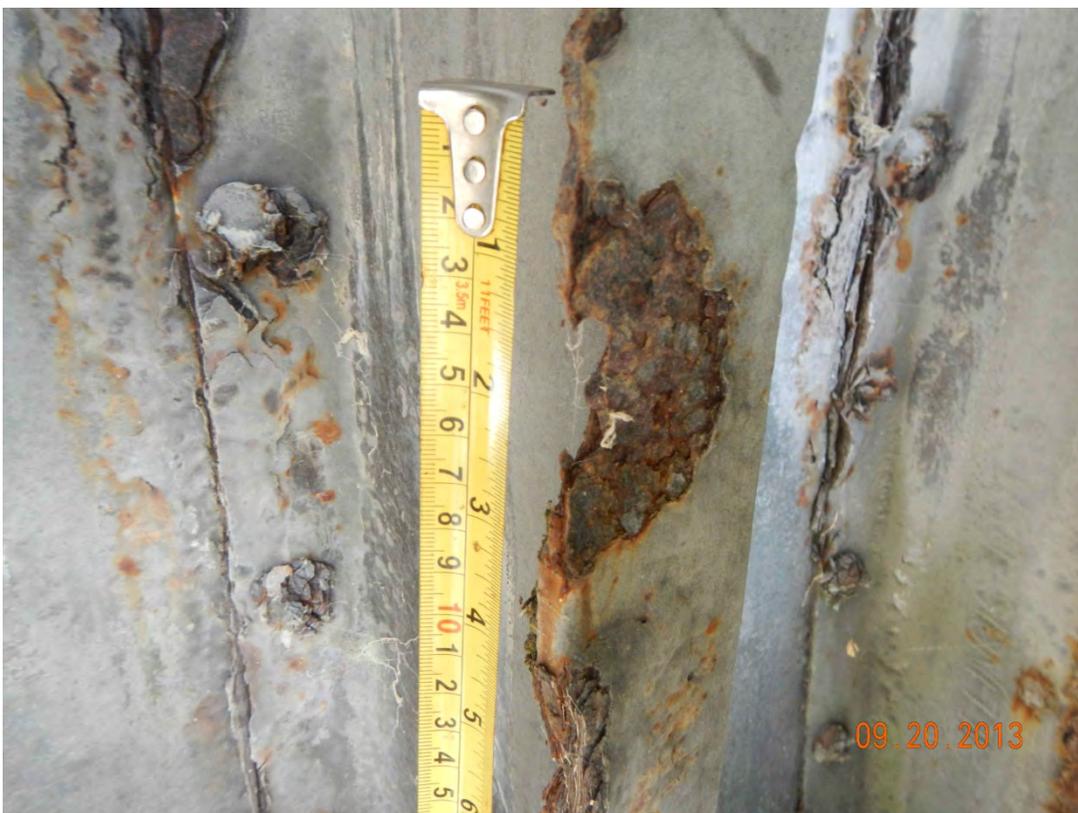
Photo 34: Gate 3 – vertical member 3rd from left with corrosion and section loss on flange

Photo 35: Gate 3 – vertical member 3rd from left with corrosion and section loss on flange

Photo 36: Gate 3 – vertical member 3rd from left with corrosion and section loss on flange

The gates should be cleaned, sand blasted and painted. Sand blasting may reveal additional section loss which should be analyzed.

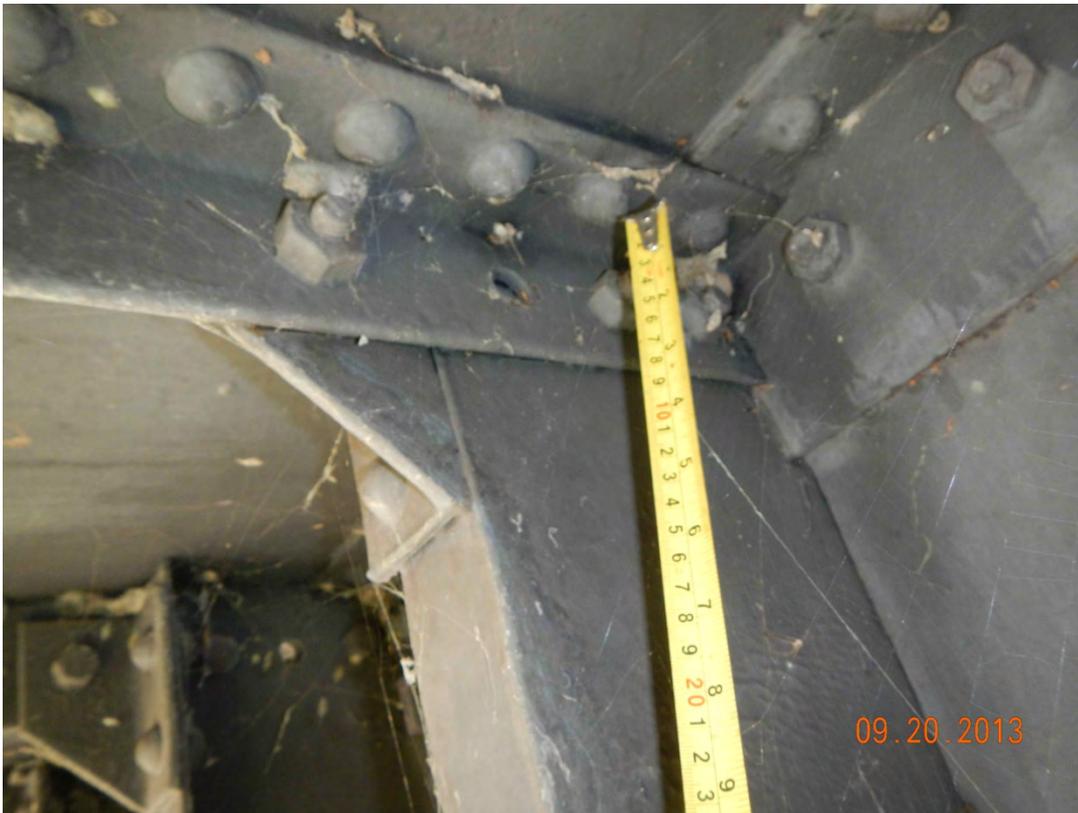
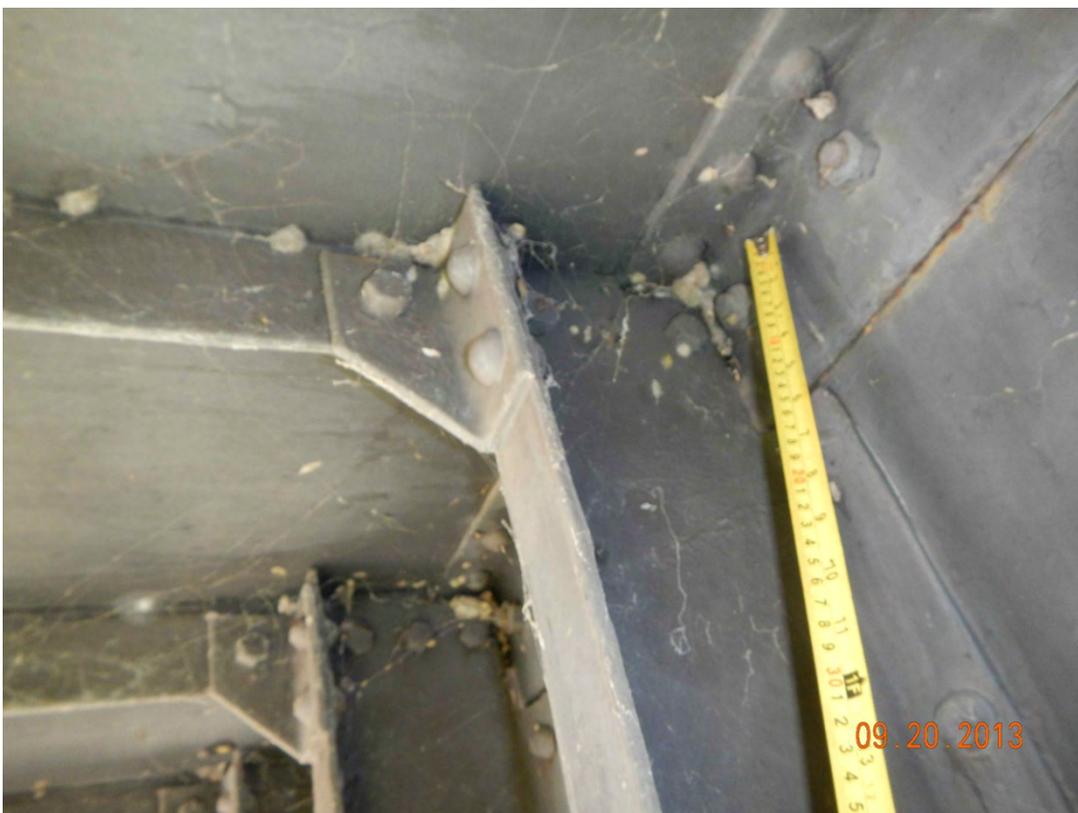
Vertical members 4th and 5th from the left are missing bolts at the top.

Photo 37: Gate 3 – vertical member 4th from left has missing bolt at top

Photo 38: Gate 3 – vertical member 5th from left has missing bolt at top

Bolt heads and nuts with section loss should be replaced and any empty bolt holes should be filled. Any new hardware shall be high strength structural bolts and nuts of matching size.

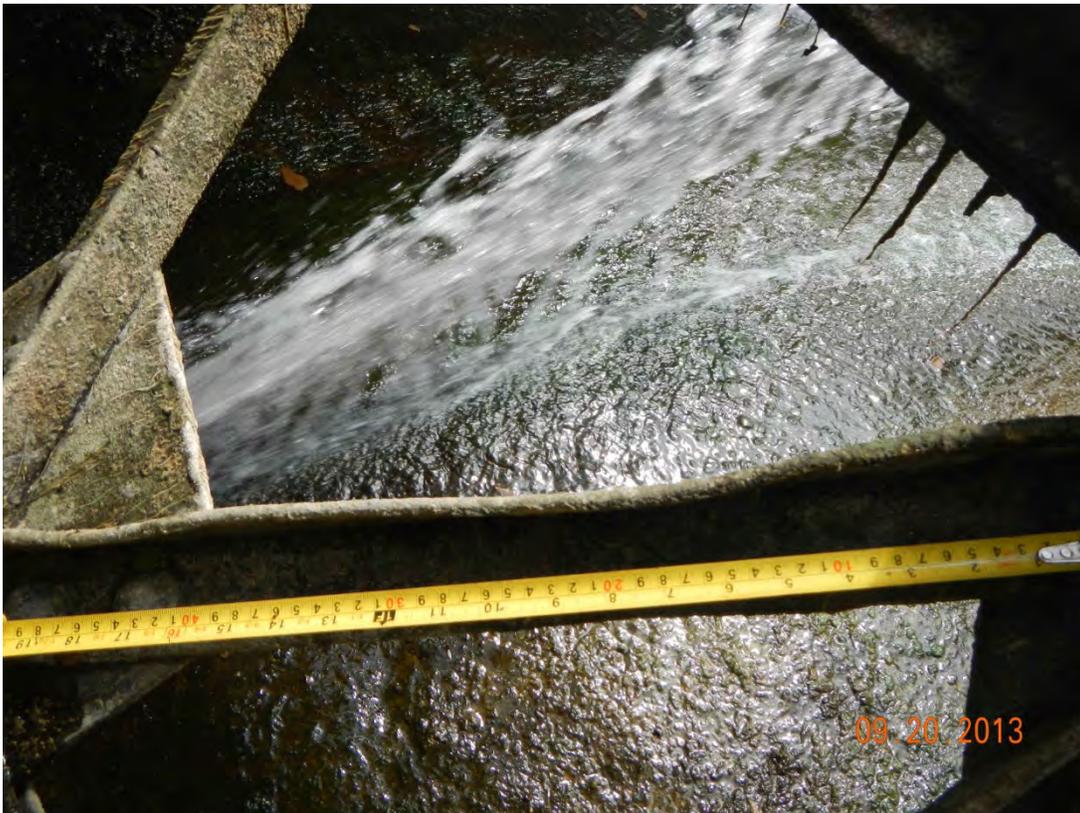
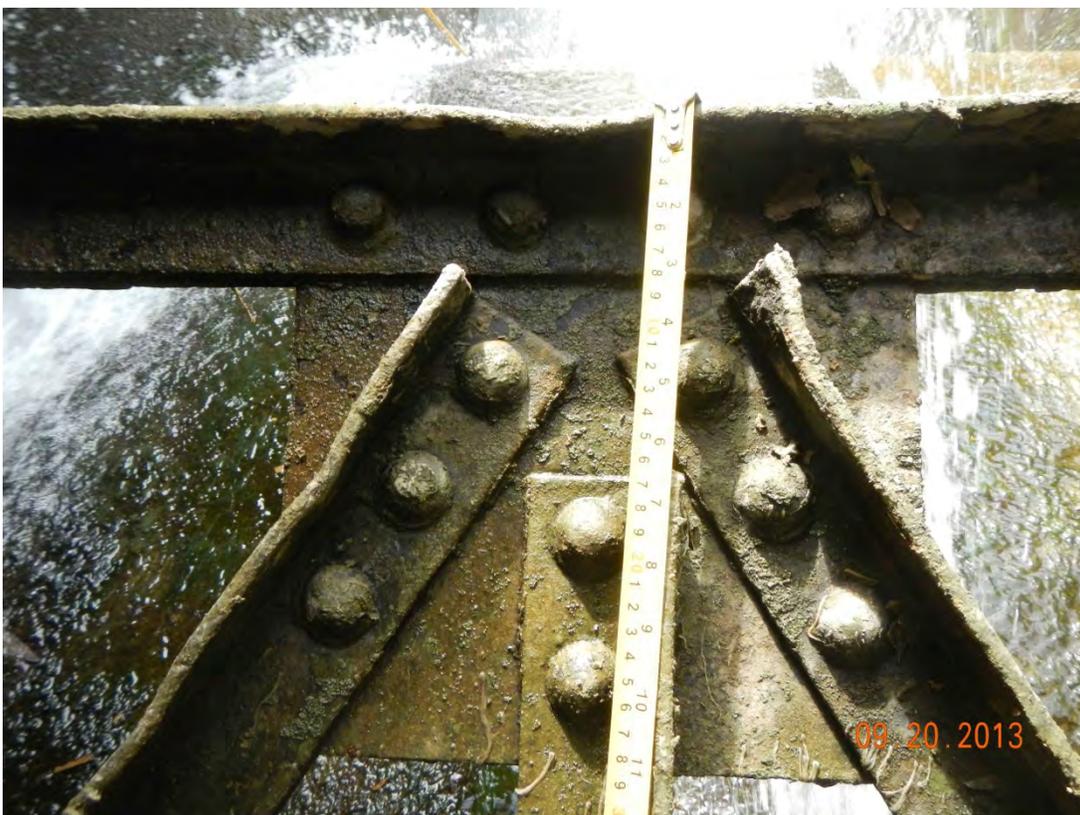
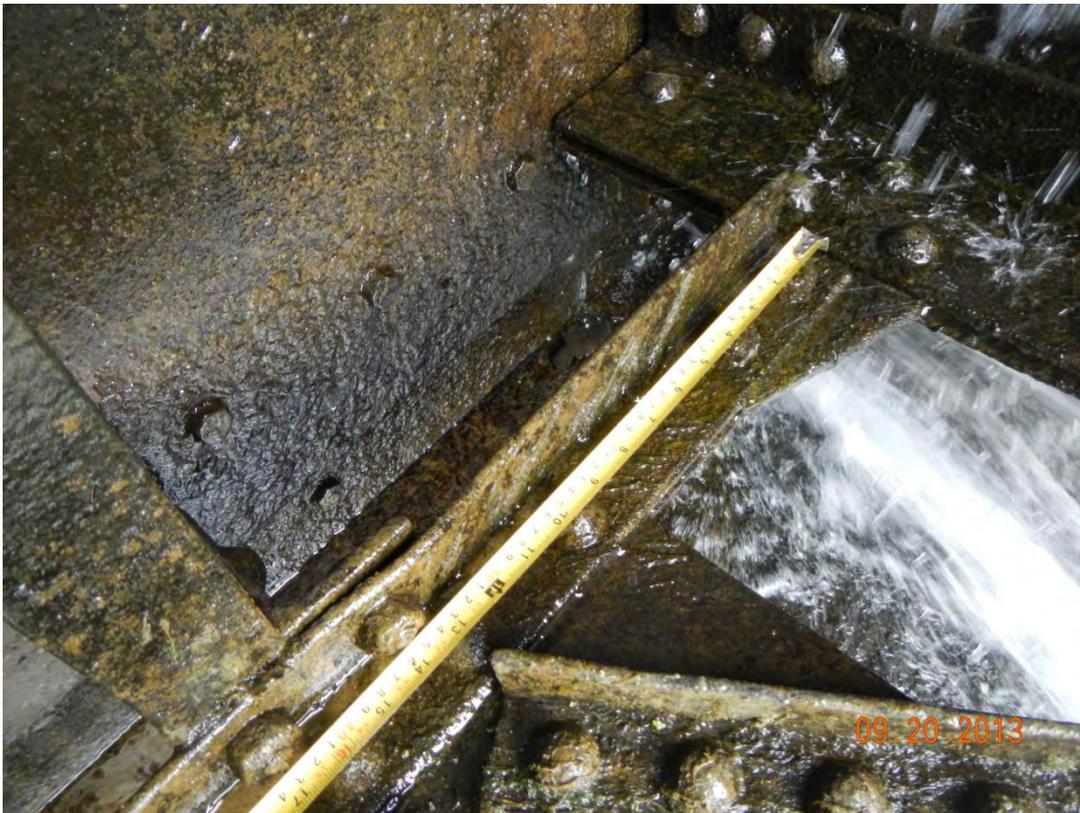
The outstanding legs of the angles of the bottom horizontal truss are bent.

Photo 39: Gate 3 – bottom horizontal truss diagonal, vertical leg of angle bent

Photo 40: Gate 3 – bottom horizontal truss, vertical leg of angles bent

Photo 41: Gate 3 – bottom horizontal truss, vertical leg of angle bent

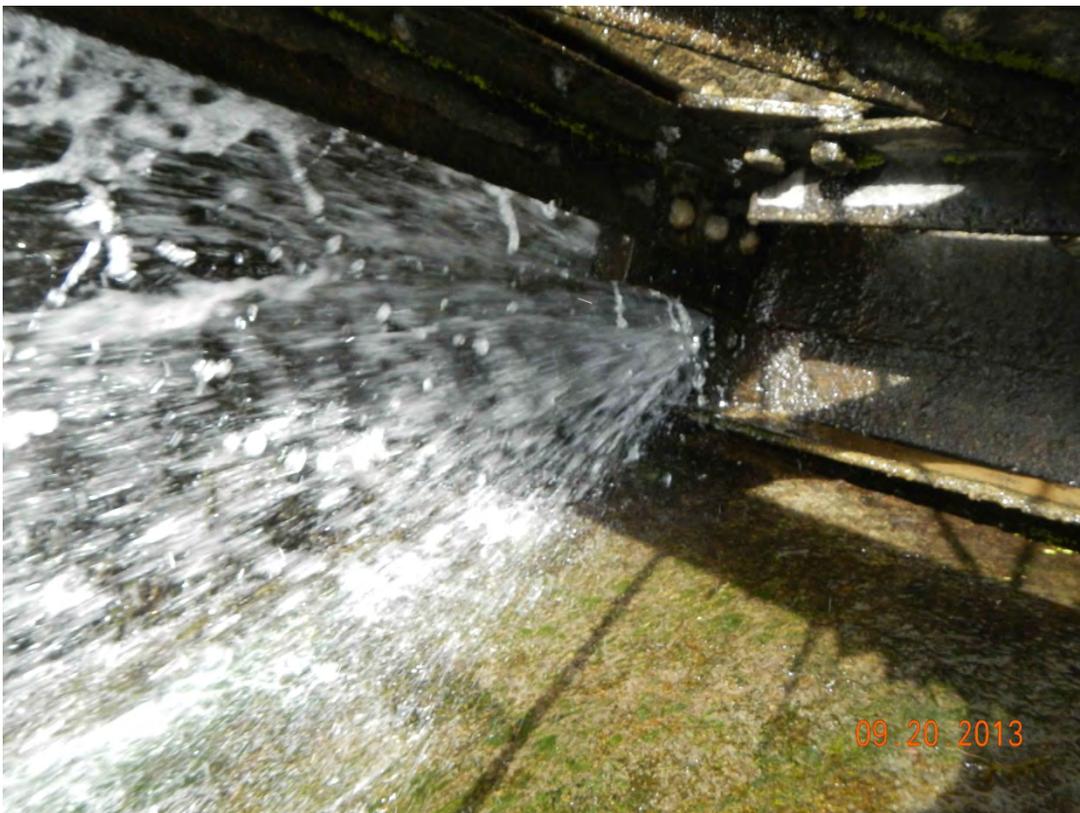
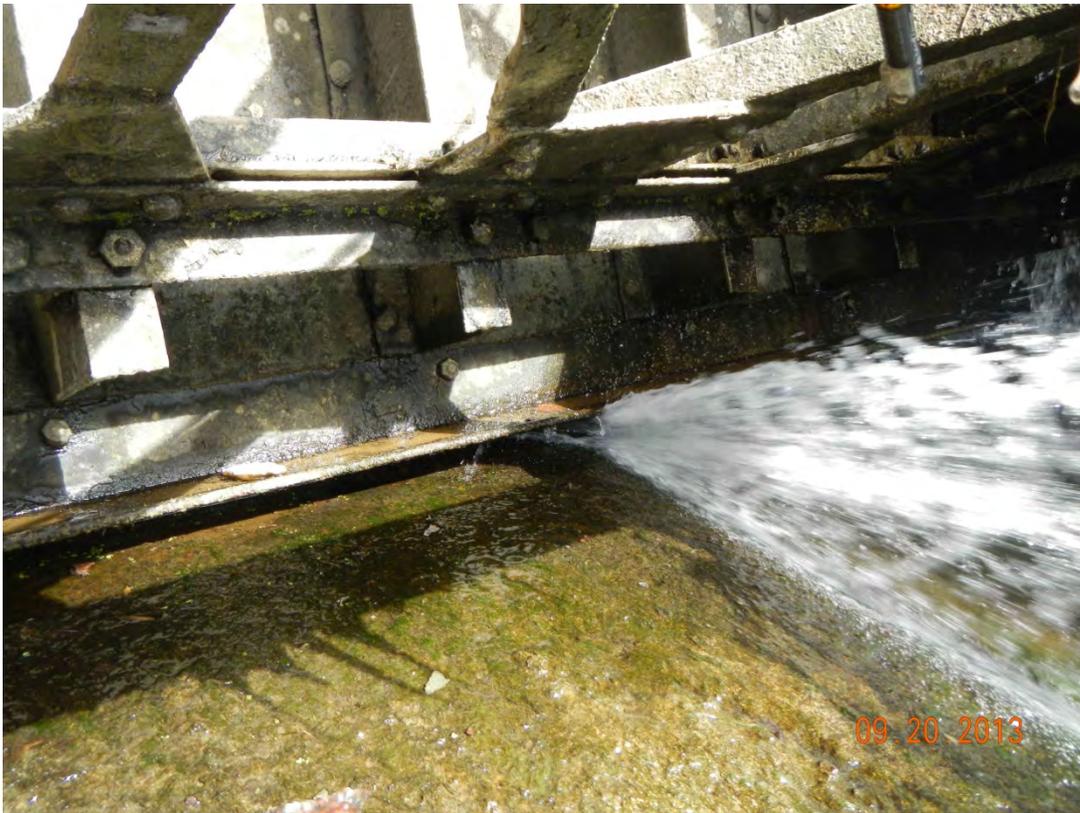
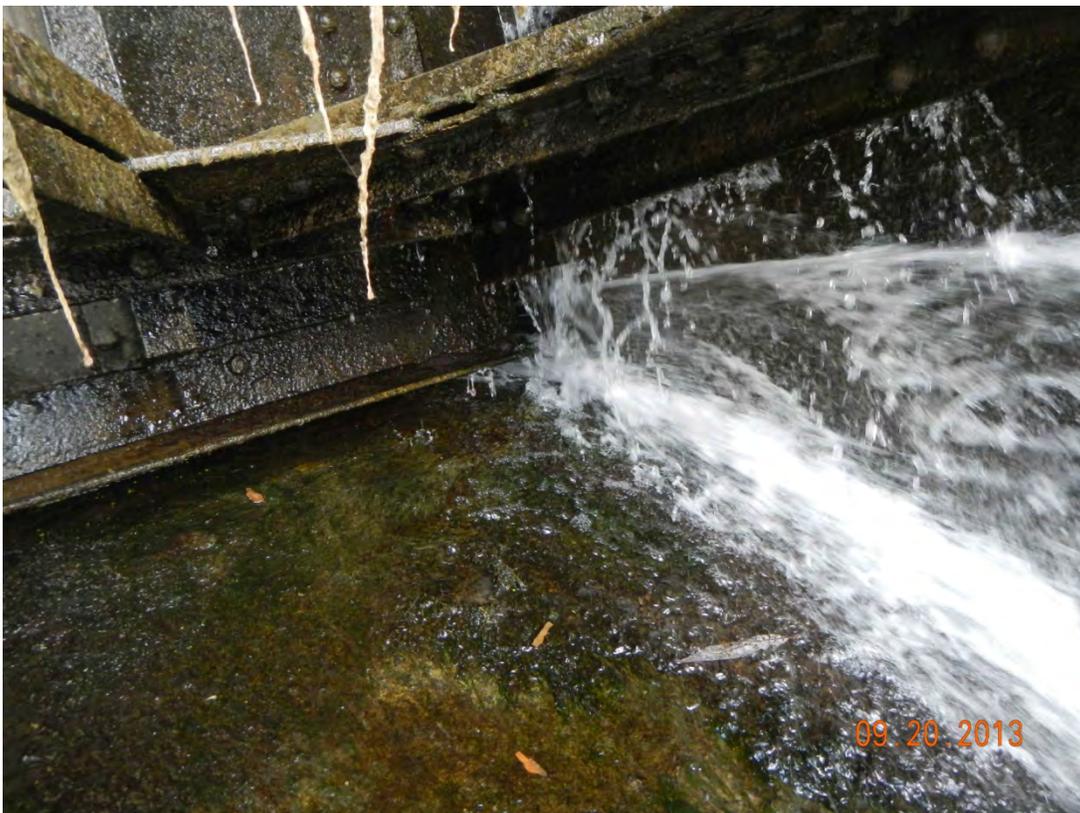
The bottom seals leak.

Photo 42: Gate 3 – leak at bottom right corner

Photo 43: Gate 3 – leak at bottom seal near middle of gate

Photo 44: Gate 3 – leak at bottom left corner

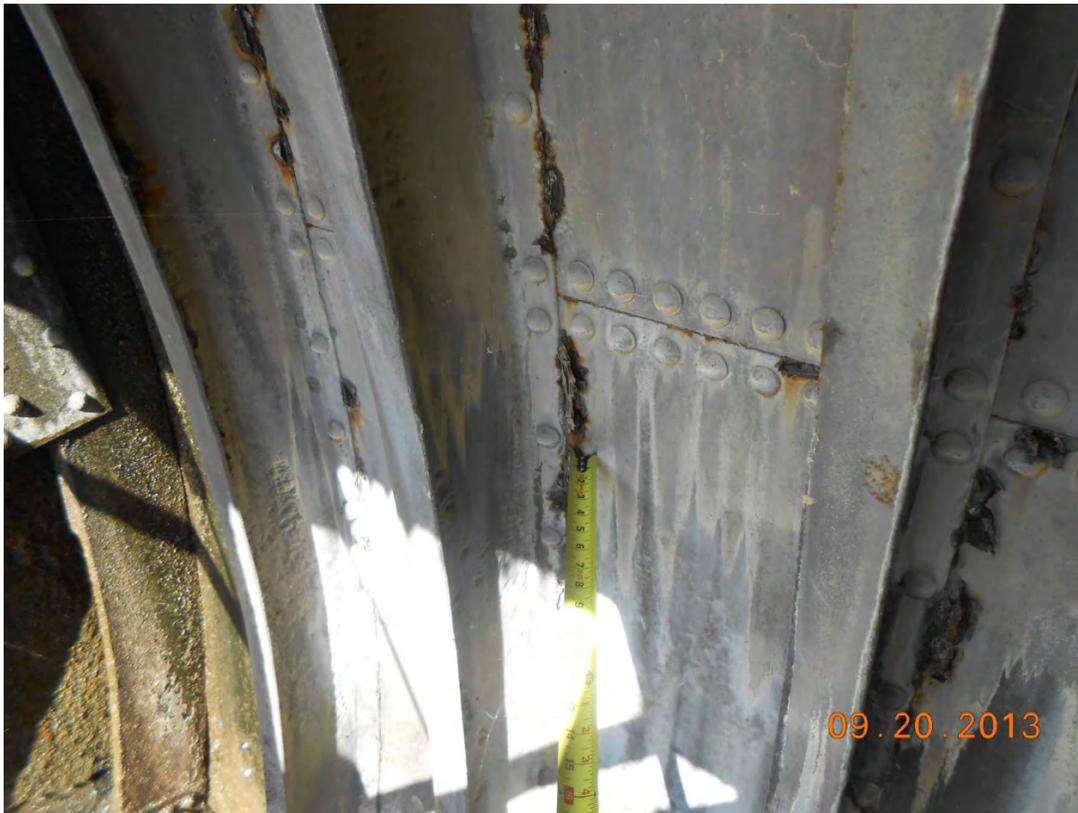
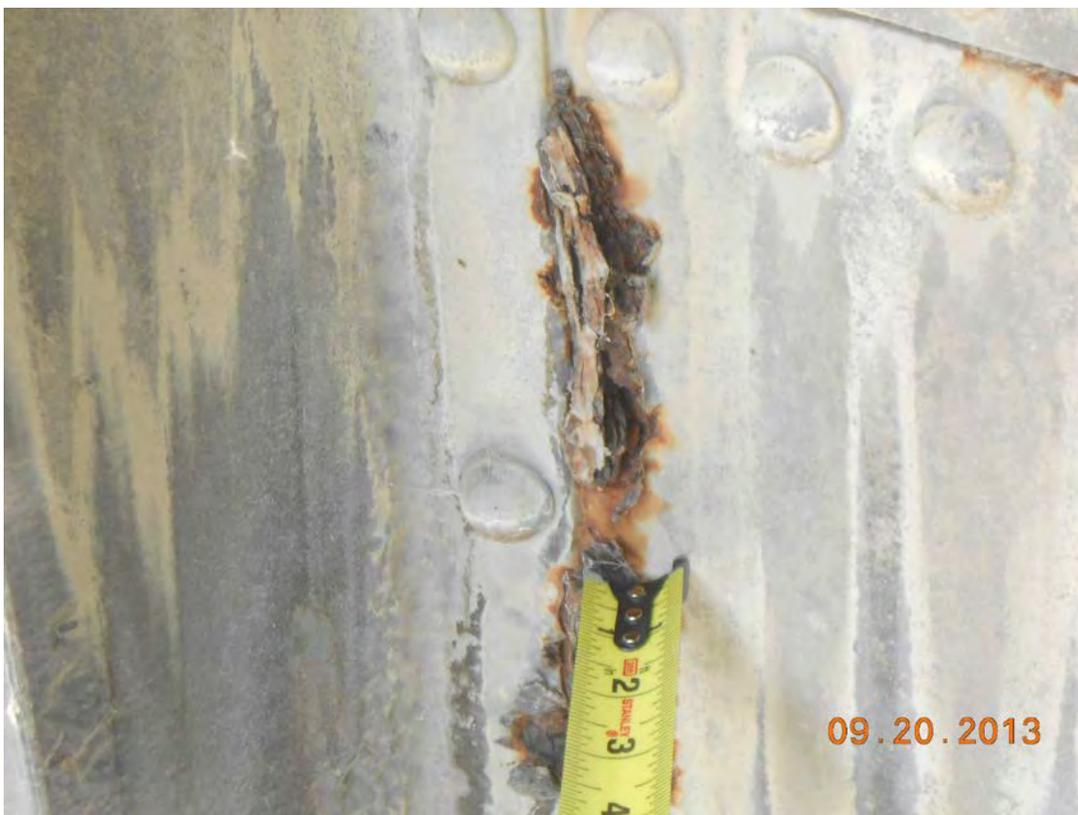
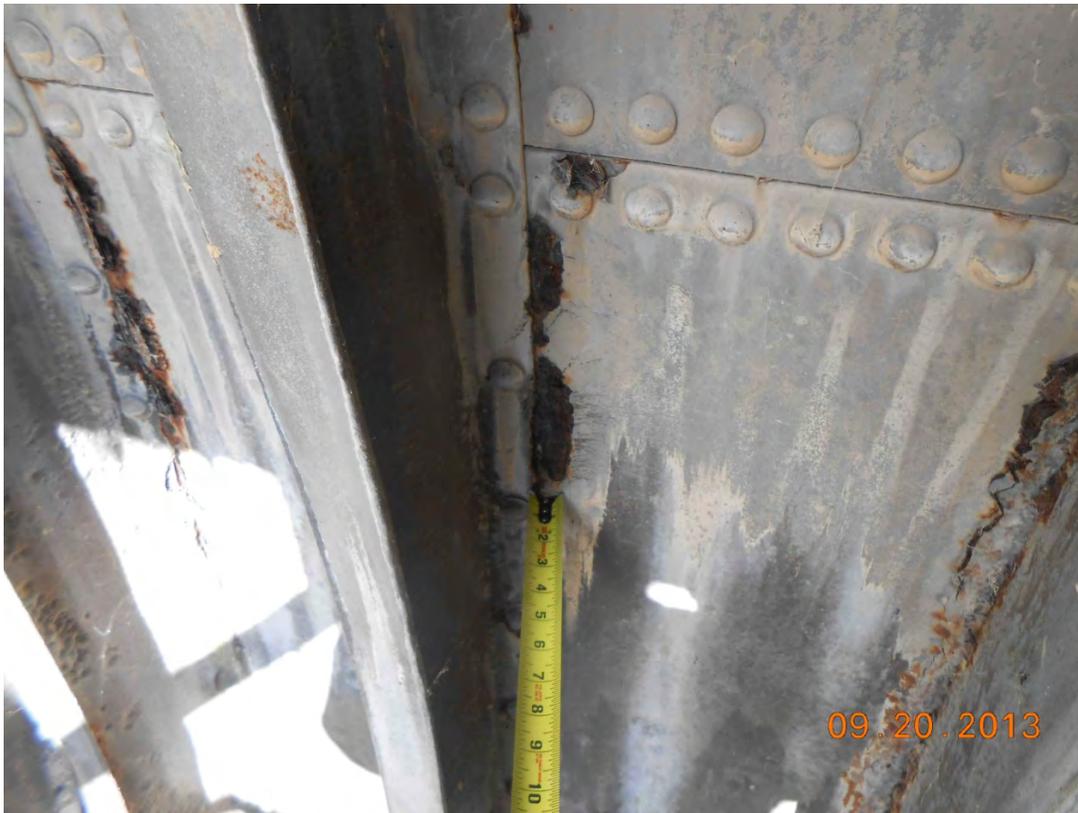
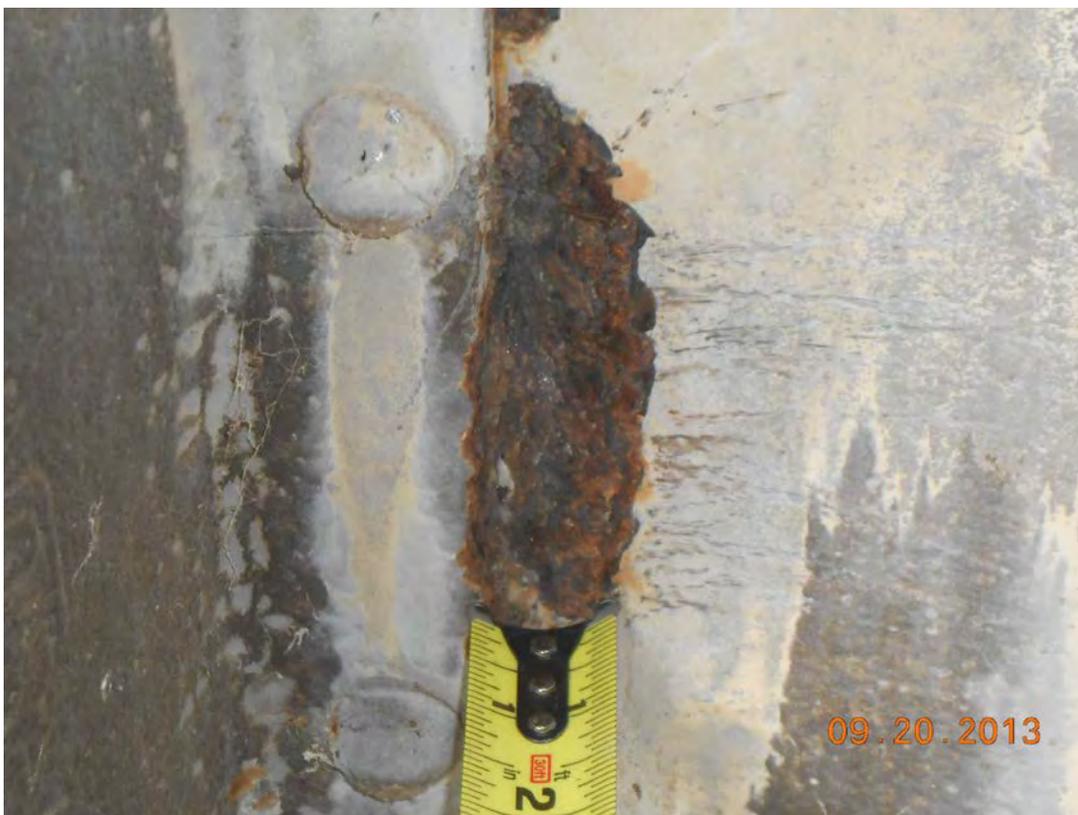
There is laminating corrosion at the skin plate and vertical beams. After removal of the laminations, it appears the thickness of the skin plate is reduced by 1/16 inch.

Photo 49: Gate 4 – laminating corrosion at skin plate and vertical beam

Photo 50: Gate 4 – laminating corrosion at skin plate and vertical beam

Photo 51: Gate 4 – laminating corrosion removed at skin plate and vertical beam

Photo 52: Gate 4 – laminating corrosion removed at skin plate and vertical beam

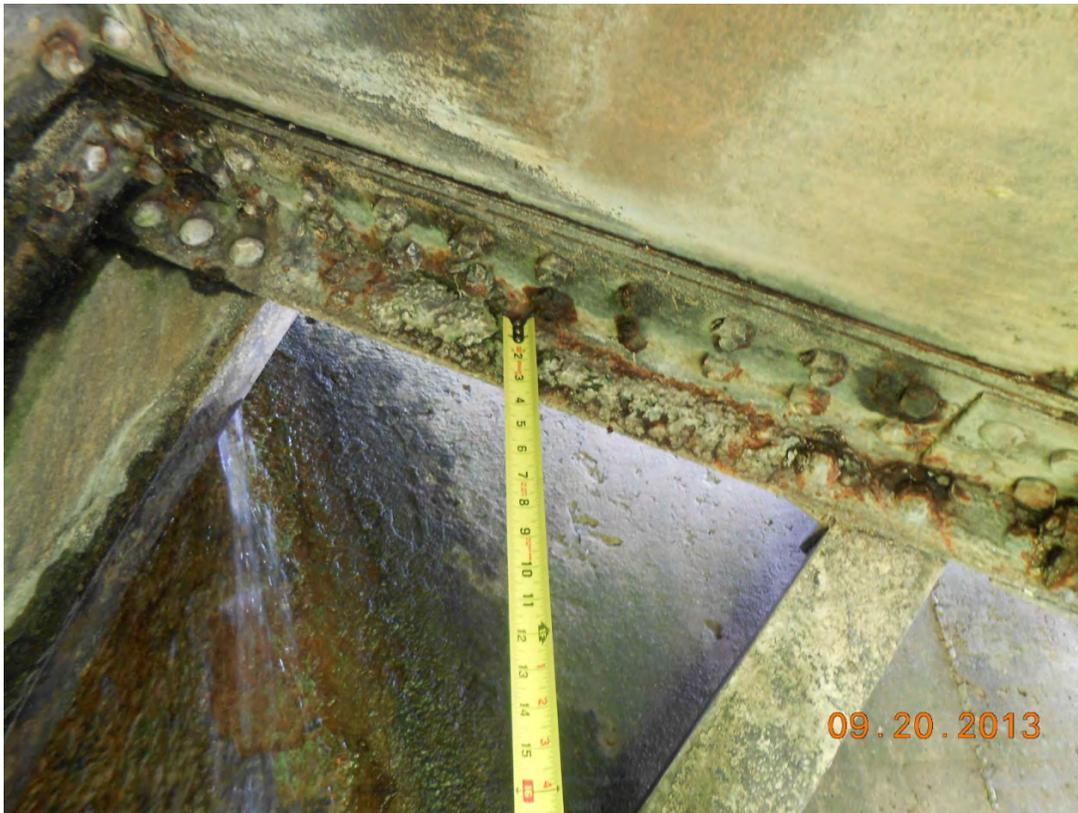
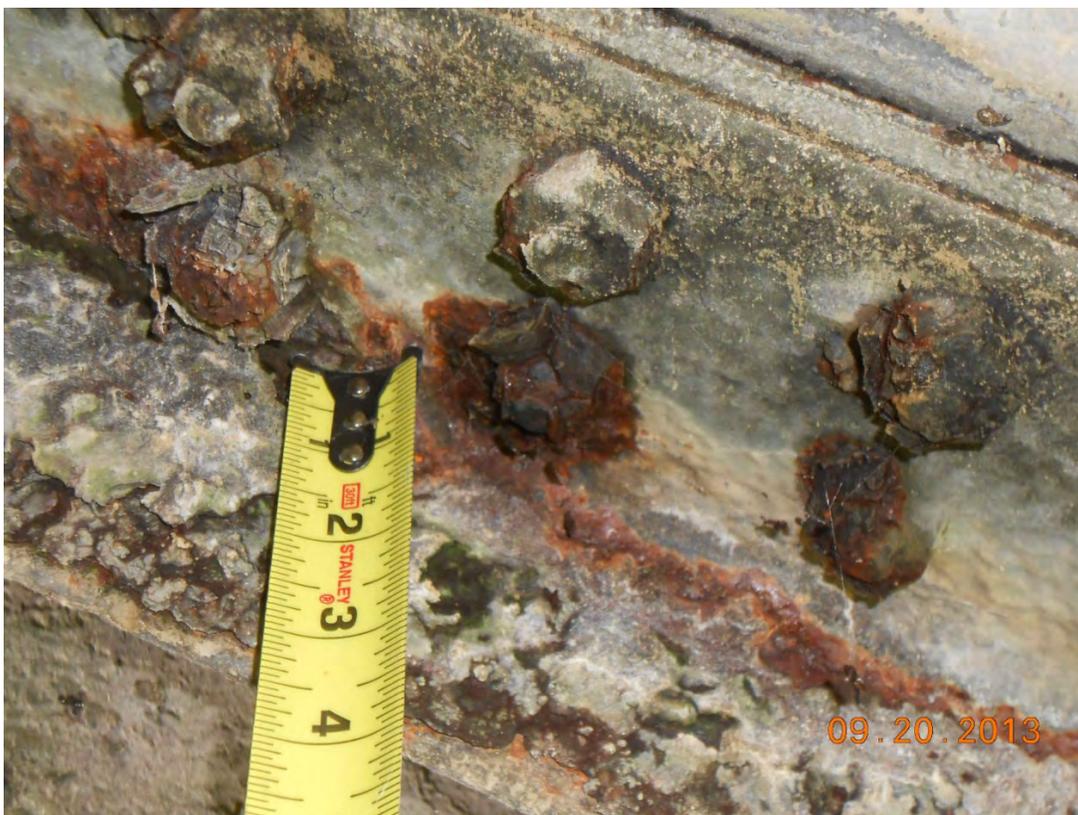
There is severe corrosion of the connection hardware causing section loss of the bolt heads and nuts.

Photo 53: Gate 4 – severe corrosion of nuts at top left arm near skin plate

Photo 54: Gate 4 – severe corrosion of nuts at top left arm near skin plate

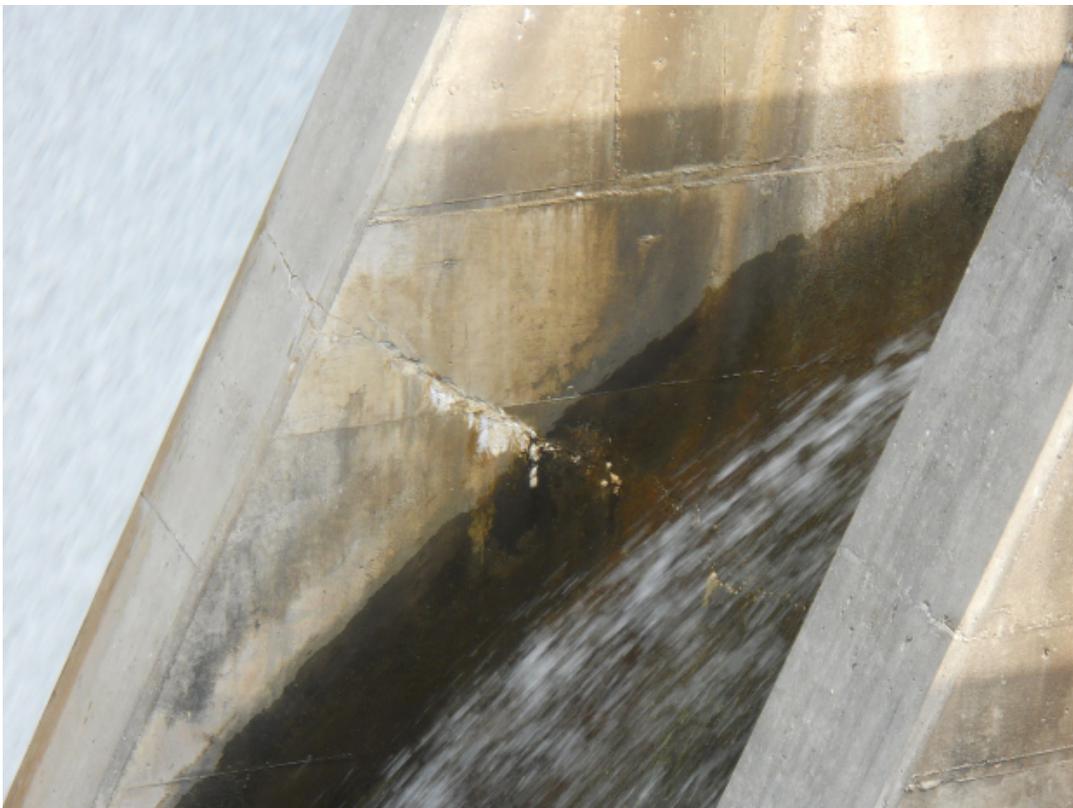
Photograph 4: Gates 2-4 – Cracking on Abutment 4

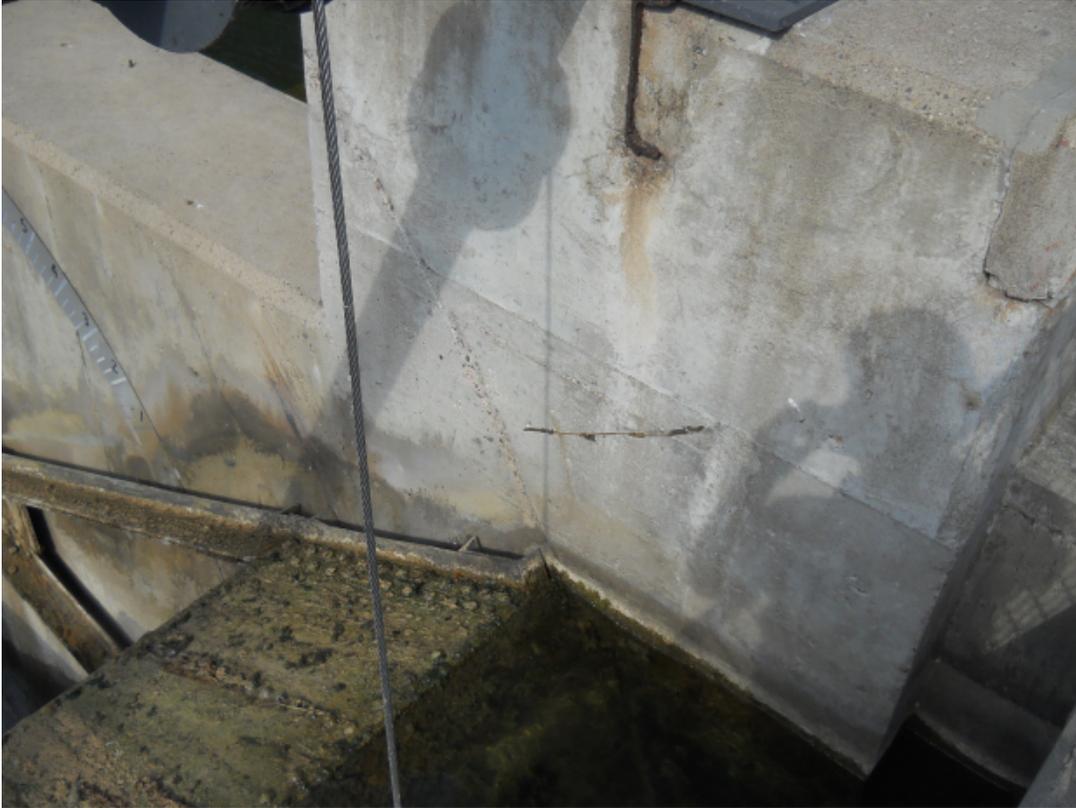
2. Tainter gates 2 and 4 were inoperable during the inspection, gate 3 was functioning correctly. The trained operator, Aaron Mason, DNR Willow River State Park Manager, noted that gate 2 binds against the abutment wall, and gate 4 has not been operable for approximately one year. Photo 5 on Appendix D shows scrape marks from the gate rubbing against the abutment wall; this causes too much friction for the winch to overcome. Further investigation into the cause of the inoperable gates was performed by the DNR. It was found that the winches may not be lifting the gates plumb which could cause the gates to become wedged between the abutments. Further investigation into the actual cause of the inoperable gates is necessary.

Photograph 5: Gates 2-4 – Evidence of Gate 4 Binding on Abutment

The gates must be repaired; the loss of these gates greatly reduces the dam's ability to pass high flows. The gates should be fixed pending the results of the spillway capacity evaluation.

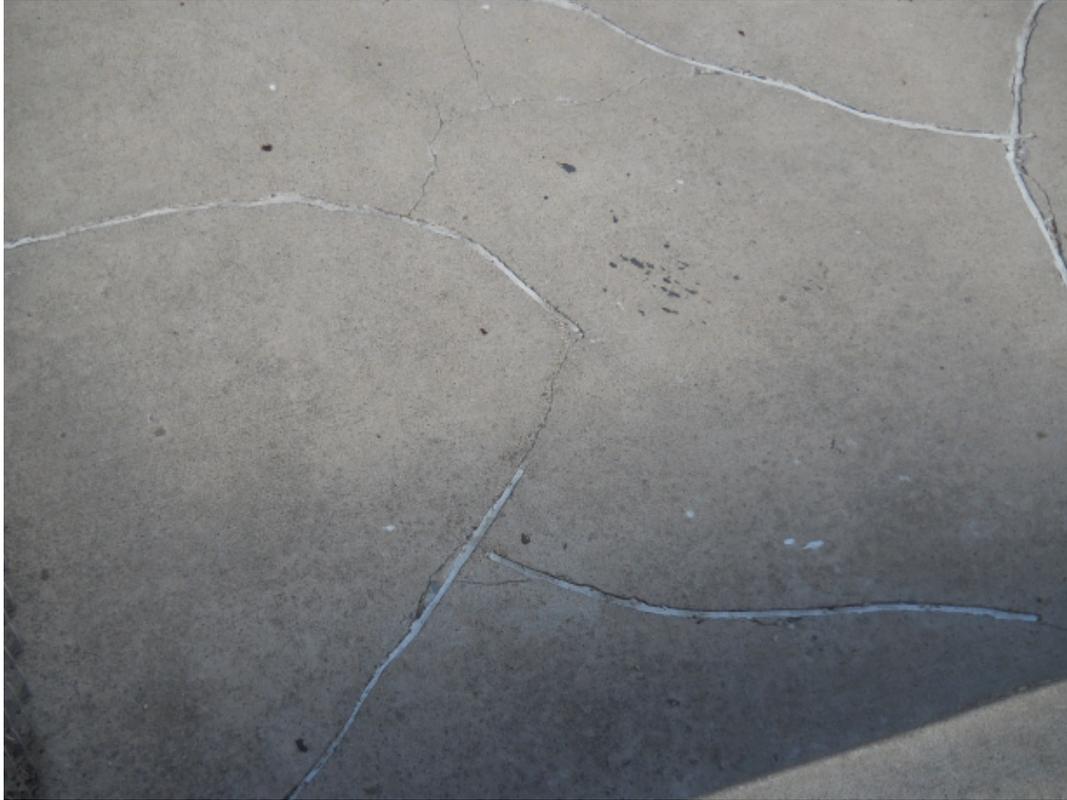
Photograph 7: Walkway Cracking
